## ВОЗДЕЙСТВИЕ ВОЛН ЦУНАМИ НА ПОБЕРЕЖЬЕ И СООРУЖЕНИЯ

## TSUNAMI ACTION ON COASTS AND CONSTRUCTIONS

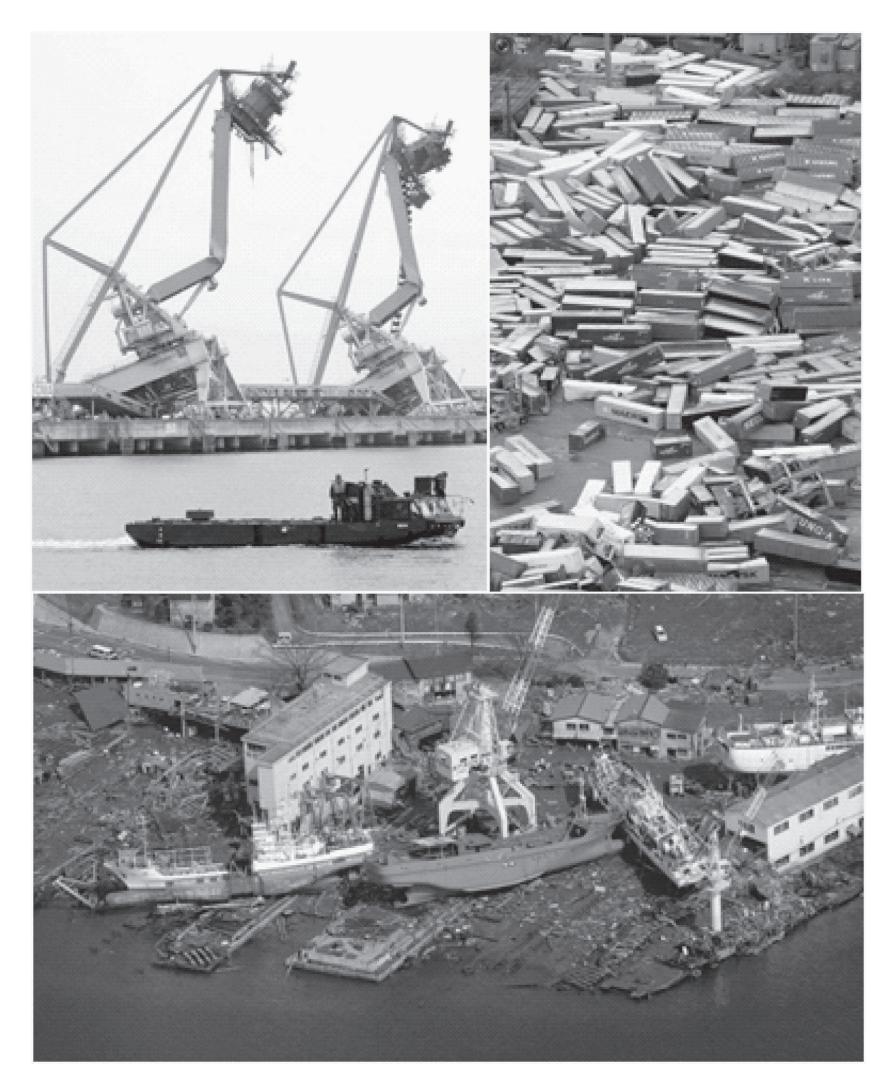
Fig. 3. The damage to the Port of Sendai caused by the Great Tohoku, Japan Earthquake and Tsunami in March 2011. Рис. 3. Повреждение Порта Сендая, вызванного Большим Землетрясением и Цунами в марте 2011.

«Many dock warehouses and loading machines were inundated and destroyed. Containers and cars were washed away to the sea» [7] — all these contributed to increased and extensive damage in harbors and ports. The Great East Japan Earthquake and Tsunami (2011) caused severe damages to ports and harbors along the Pacific coast. Fig. 3 clearly shows the extent of damage to the Sendai Port, Japan. In the Kamaishi Port the GEJE tsunami dumped a cargo ship of 175,000 tons on top of a pier (Fig. 4, a) and eroded ground around the concrete building is also shown in Fig. 4, b. The reader is advised to refer to [7] for a detailed coverage of damages to Japanese ports due to the Great East Japan Earthquake and Tsunami (2011).

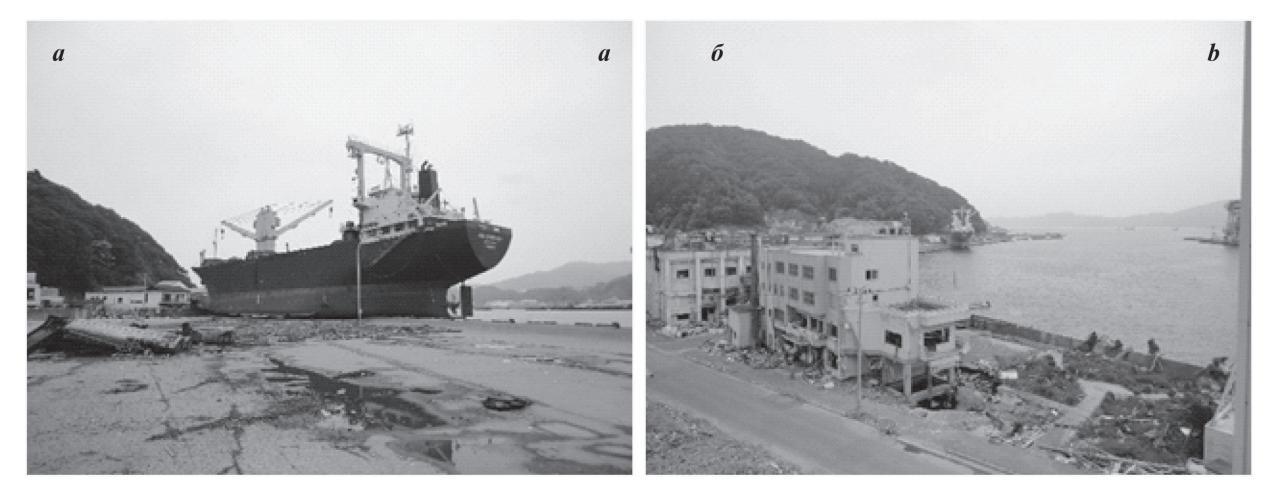
Fig. 4. A cargo ship dumped to a pier in the Kamaishi Port, Japan (*a*) and the scour around concrete building in Kamaishi by the Great East Japan Earthquake and Tsunami (*b*) (photos by Ahmet Cevdet Yalciner).

Рис. 4. Грузовое судно, сваленное к пирсу в Порту Камаиши, Япония (*a*) и разрушения вокруг бетонного здания в Камаиши Большим Восточным Землетрясением Японии и Цунами (б) (фотографии Ахмета Ялченира).

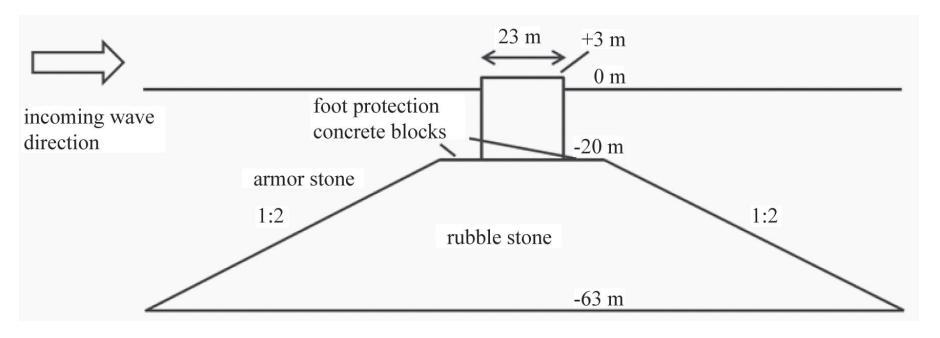
Fig. 5. Cross-section through the Kamaishi South breakwater [10].

Рис. 5. Поперечное сечение через волнорез Юга Камаиши [10].

8500 m of breakwaters including dedicated tsunami breakwaters like the World record breakwater at Kamaishi collapsed during the 2011 tsunami [8]. It was constructed in a maximum water depth of 63 m consisting of two sections: one, 670 m length and the other 770 m length. A cross-section is indicated in Fig. 5.

The failure of the breakwater has been investigated using physical and numerical modelling performed by the Port and Airport Research Institute (PARI).

The investigation showed that the failure of breakwater was due to three effects caused by the tsunami overflow. One, water level difference between the two sides of the breakwater resulted in a rise in the lateral force, two, the overflow scouring causing a decline in friction between the caisson and mound leading to sliding [9], and three the seepage between the blocks (50 cm distance) causing additional scouring of the back fill materials.

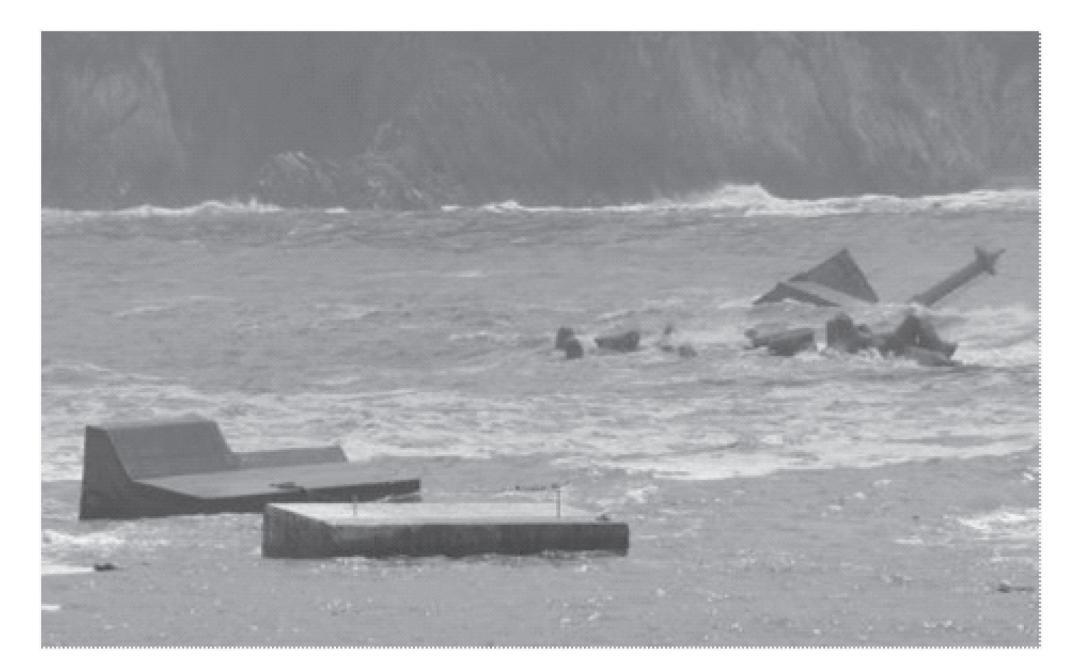
Fig. 6. A variety of concrete debris from breakwater and seawalls offshore of Tarō which observed during the 2011 EEFIT mission [3].

Рис. 6. Множество бетонных обломков от волнореза и дамб на расстоянии от берега Tarō, которые обследовались во время полевых исследований 2011 г. [3].

Fig. 6 shows a variety of concrete debris which were the parts of breakwater and seawall in the bay of Tarō. The picture was taken during the 2011 EEFIT survey. Clear effects of scour on the sea dikes is indicated in Fig. 7 where effects of scour on the lee side causing to insufficient cracking of reinforced concrete lattice work.

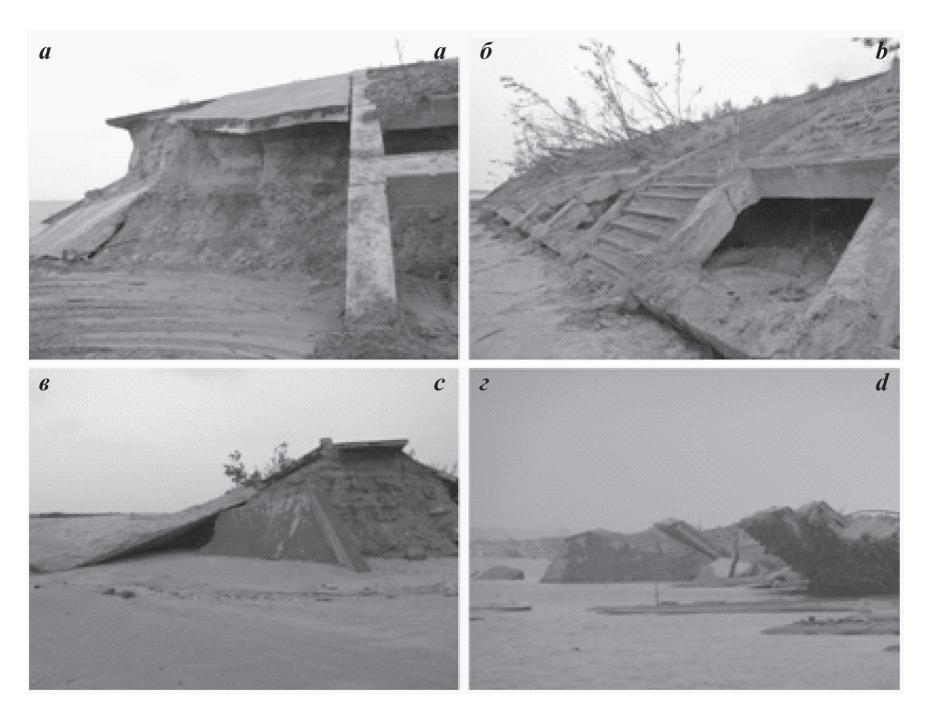
Fig. 7. Failure of Yamamoto sea dikes, captured during the 2011 EEFIT mission.
a — exposed sand core on the lee side; b — proof of sand core having been washed out;
c — exposed section through the sea dike; d —debris of the dike at the distance, lying in pools of seawater to the lee side of the structure having not subsequently drained away [3].

Рис. 7. Фото прорыва морских плотин Ямамото, обнаруженых во время полевых исследований EEFIT 2011 г. *а* — размытие песковой основы; *б* — размытие песковой основы с другой стороны; *в* — разрушение секции морской дамбы; *г* — разрушение плотины [3].

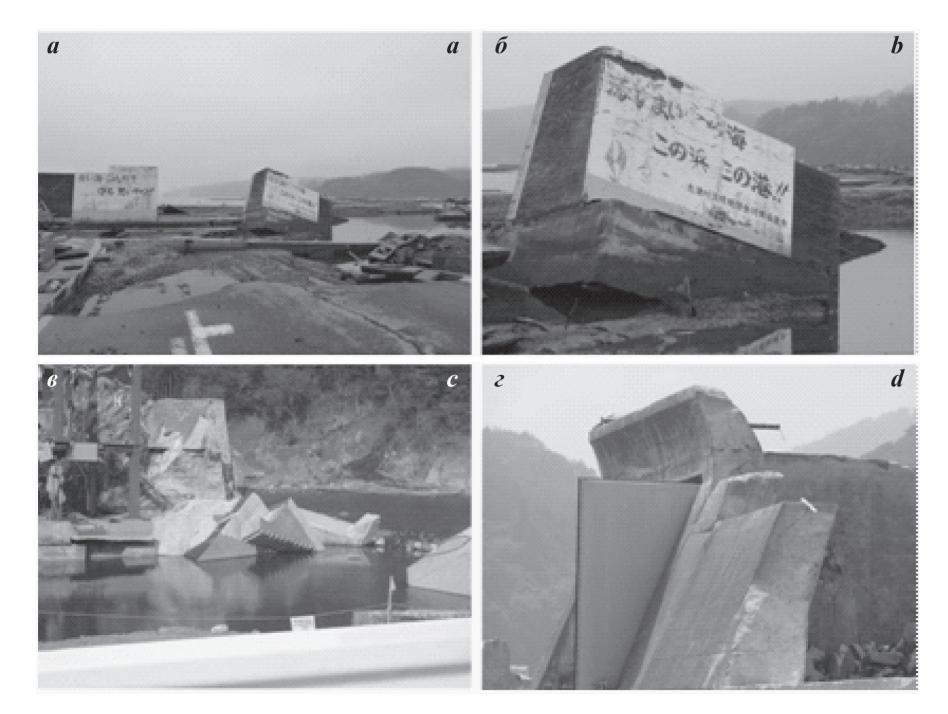
Fig. 8. Damage to the seawall observed during the 2011 EEFIT Mission. *a* — failure of seawall and quay at Minamisanriku; *b* — close-up of seawall block at Minamisanriku indicating no interlinkages; *c* — restoration of the seawall at Miyako Bay; *d* — remaining seawall buttress at Tarō [3].

Рис. 8. Повреждение дамбы, наблюдаемой во время полевых обследований 2011 г. *а* — дамба и причал в Минамисанрику; *б* — дамба в Минамисанрику; *в* — дамба в заливе Мияко; *г* — оставшаяся часть дамбы в Tarō [3]. **Discussion and conclusions.** Tsunamis are high-impact, long-lasting disasters, which in most cases allow for only minutes of warning before impact. The amount of energy behind huge tsunami waves can cause severe destruction when it hits land and consequently causes massive loss of human life. The impact of tsunami can be considered in social, environmental, and economic dimensions. The social impact can be seen in destruction of life and property, health crisis and disease. Tsunamis may cause massive environmental impact by devastating effect on insects, animals, plants, also, damage on natural resources, e.g., contamination of soil and water, a permanent change to the landscape, massive amount of disaster debris, and hazardous materials (toxic substances, and industrial raw materials and chemicals). The March 11, 2011 Japan earthquake and tsunami economic damage costs was \$150 billion.

Seawall failures of both gravity seawalls and compacted sand core structures were also observed (Fig. 8). Failure mechanisms of the Tarō seawall included the removal of rear slope protection blocks due to the tsunami overflow, the collapse of the crest parapet due to impulsive fluid forces, the collapse of the front protection blocks due to draw-down and there was also evidence of shear failure between blocks [11].

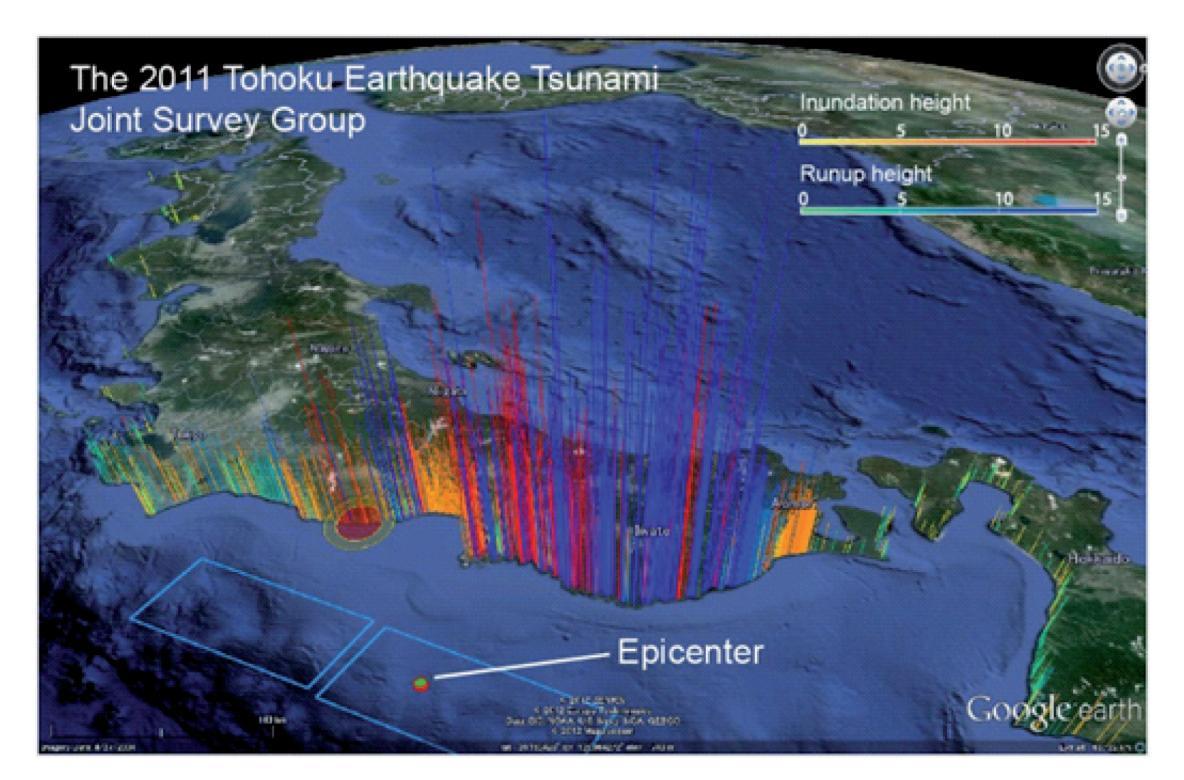
Fig. 1. 11 March 2011 Tohoku earthquake and tsunami. After the 2011 Tohoku Earthquake Tsunami Joint Survey (TTJS) Group.

Рис. 1. 11 марта 2011 г. Тохоку землетрясение и цунами. Полевые обследования Цунами Землетрясения Тохоку 2011 г. (TTJS).

The Great East Japan Earthquake (GEJE) was the fourth most powerful earthquake recorded in the past 100 years. The quake shock last for six minutes. A half hour later, a massive tsunami penetrated over 650 km of coastline (Fig. 1, see the insert), overtopping sea walls and other coastal defence structures, flooding through more than 500 km<sup>2</sup> of land causing entire towns and villages to be washed away. Japan was simply not as prepared as they estimated they were for such a disaster, e.g., causing 15,883 fatalities and 2,654 missing in northeastern Japan [4] and damage costs of \$150 billion. The Fukushima, Iwate, and Miyagi prefectures were the worst hit areas.
